### **Site Visit to Evaluate Erosion Potential near Colusa Mitigation Area**

| <b>FROM:</b><br><br>Chris Jones | <b>SUBJECT:</b><br><br>Site visit to evaluate erosion potential near Colusa Mitigation Area |

## EROSION EVALUATION NEAR COLUSA MITIGATION AREA

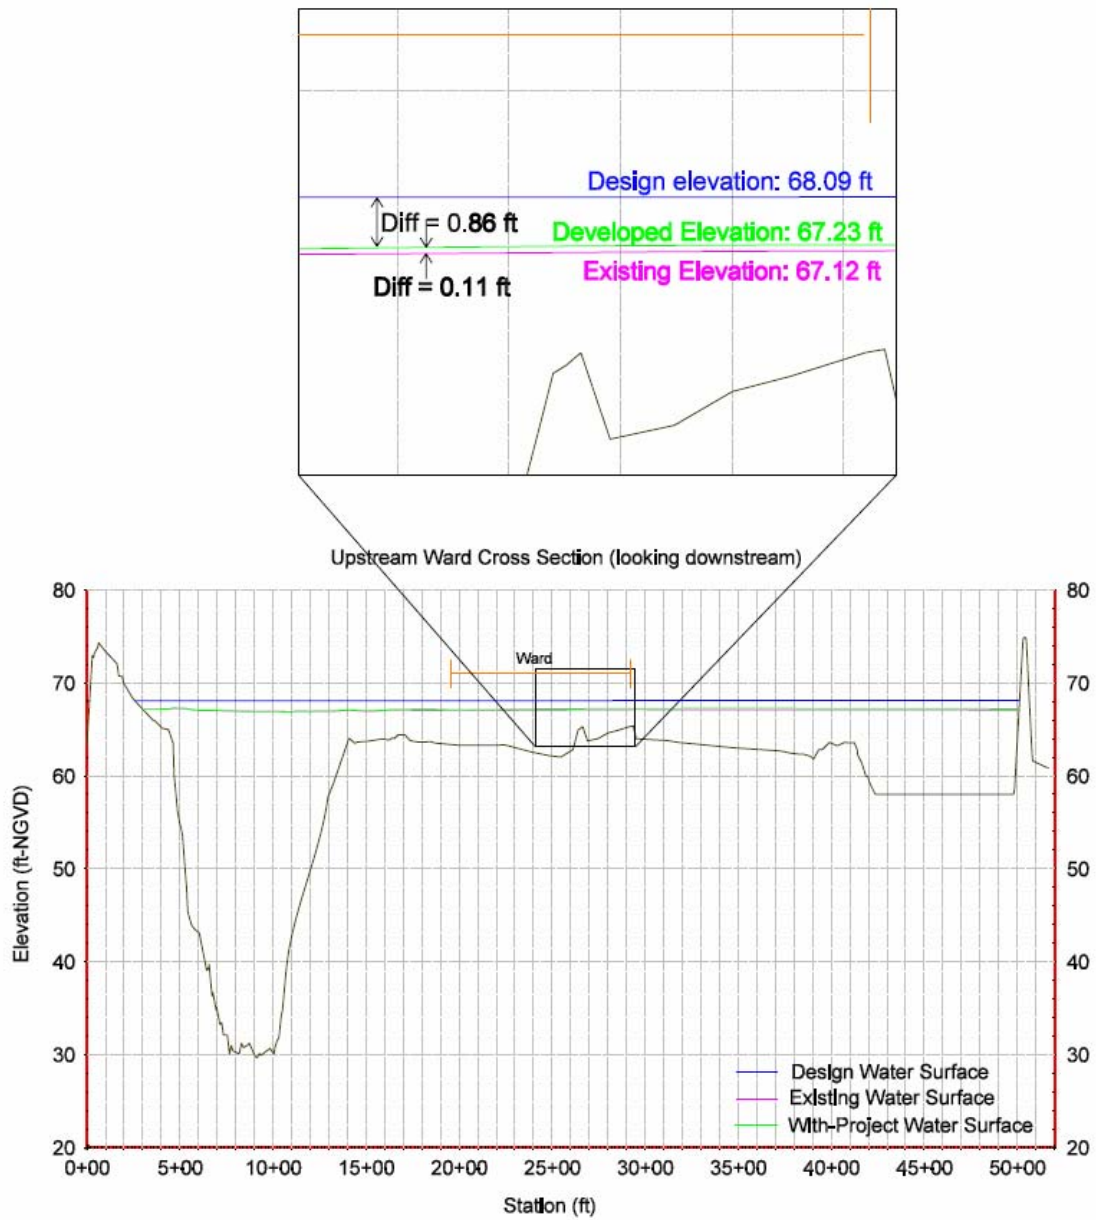
**Figure 10: Modeled water surface elevation at cross-section taken along upstream portion of Ward Tract. The gray curve shows the ground surface, i.e. levees and river-bottom. The cross section looks downstream; the left levee is on the east, and the right levee is on the west. (Ayres Associates)**

- Model results indicate that the proposed restoration project at Ward Tract would lead to very little, and very localized rise in water surface elevation. The localized rise in water surface elevation that slightly exceeds 0.10 ft would be confined to the yellow triangular area shown in **Figure 9**. The maximum increase in water surface elevation was modeled to be 0.15 ft. The maximum increase in water surface elevation along a levee was modeled to be 0.12 ft.
- The water surface remains well below the design profile: 0.5 to 1.5 feet below the design profile in the immediate vicinity of the project (see **Figure 8**). **Figure 10** indicates that the minimum difference between the design profile and the restored conditions (with project) water surface elevation at the cross-section in the affected area is 0.86 ft.

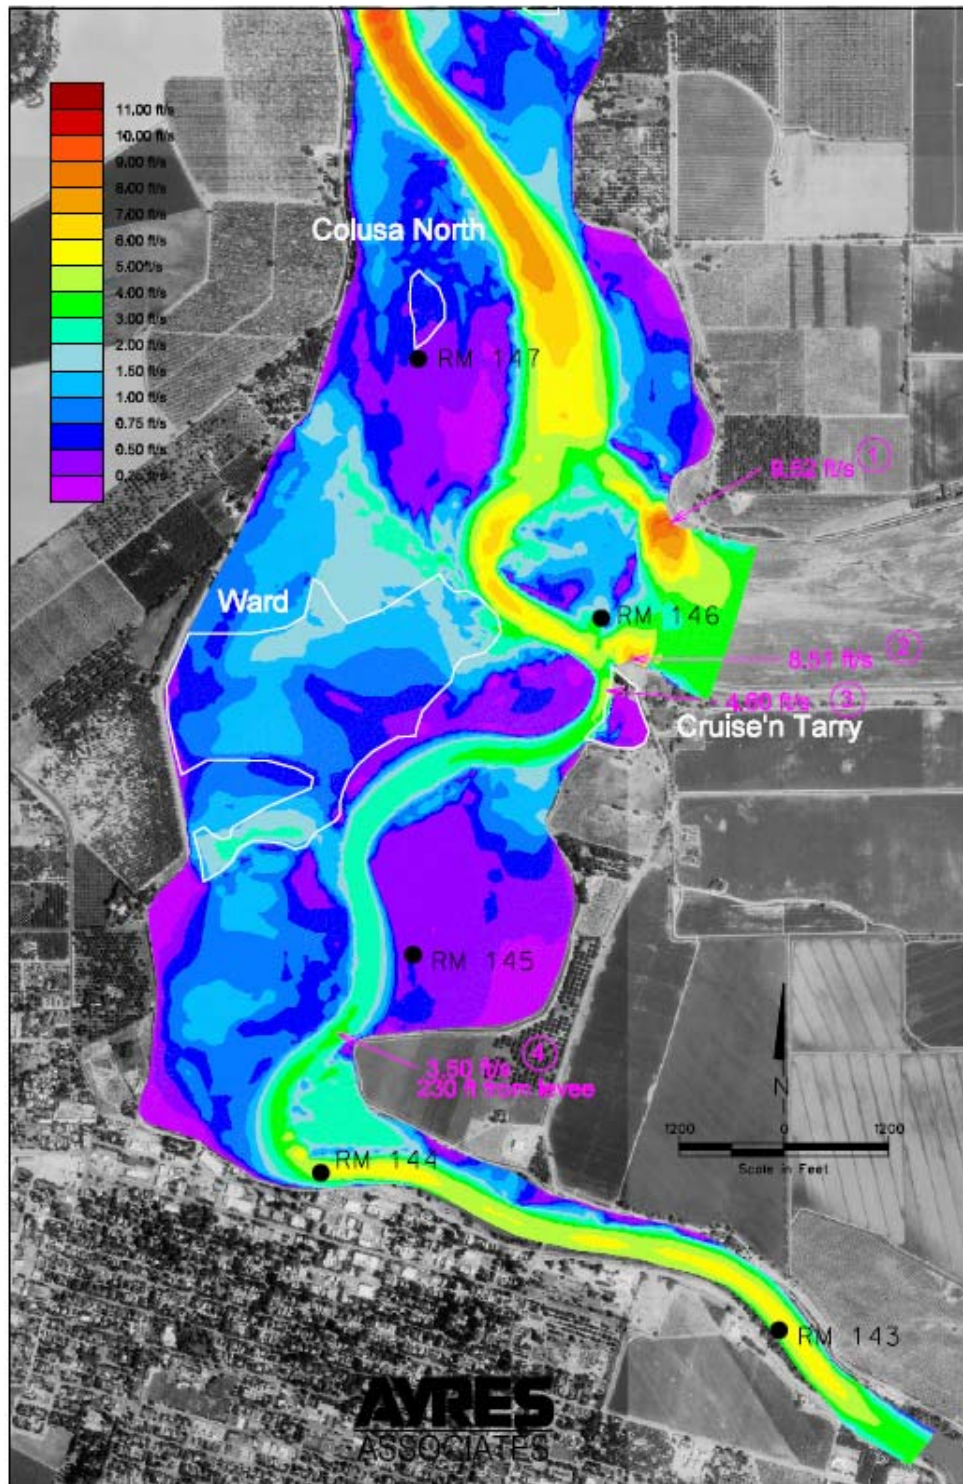
- Model results point to four areas that could be of concern under existing conditions (without project), depending on levee armoring at those sites. (See **Figure 12**).

- The model indicates that under existing conditions, when 160,000 cfs enters the Colusa Subreach, there are three locations adjacent to levees where velocities approaching or exceeding 5 ft/sec would occur. Locations 1 and 2 are located at the north and south edges of the entry to Colusa Bypass. Maximum modeled velocities there are between 8 and 10 ft/sec, in the range where armoring would likely be required for bank stability. Location 3 is at Cruise 'n Tarry. The maximum modeled velocity at Location 3 is 4.74 ft/sec, just below the 5 ft/sec threshold below which banks tend to be stable if well-vegetated.

- Under existing conditions, where the main channel curves toward the fourth location, along the East bank at river mile 144.6, velocities of up to 3.50 ft/sec occur in the center of the channel. The maximum velocity of 3.50 ft/sec occurs 230 ft out from the levee bank.

Figure 12: Modeled Existing Conditions (Without Project) velocity distribution (Ayres Associates)

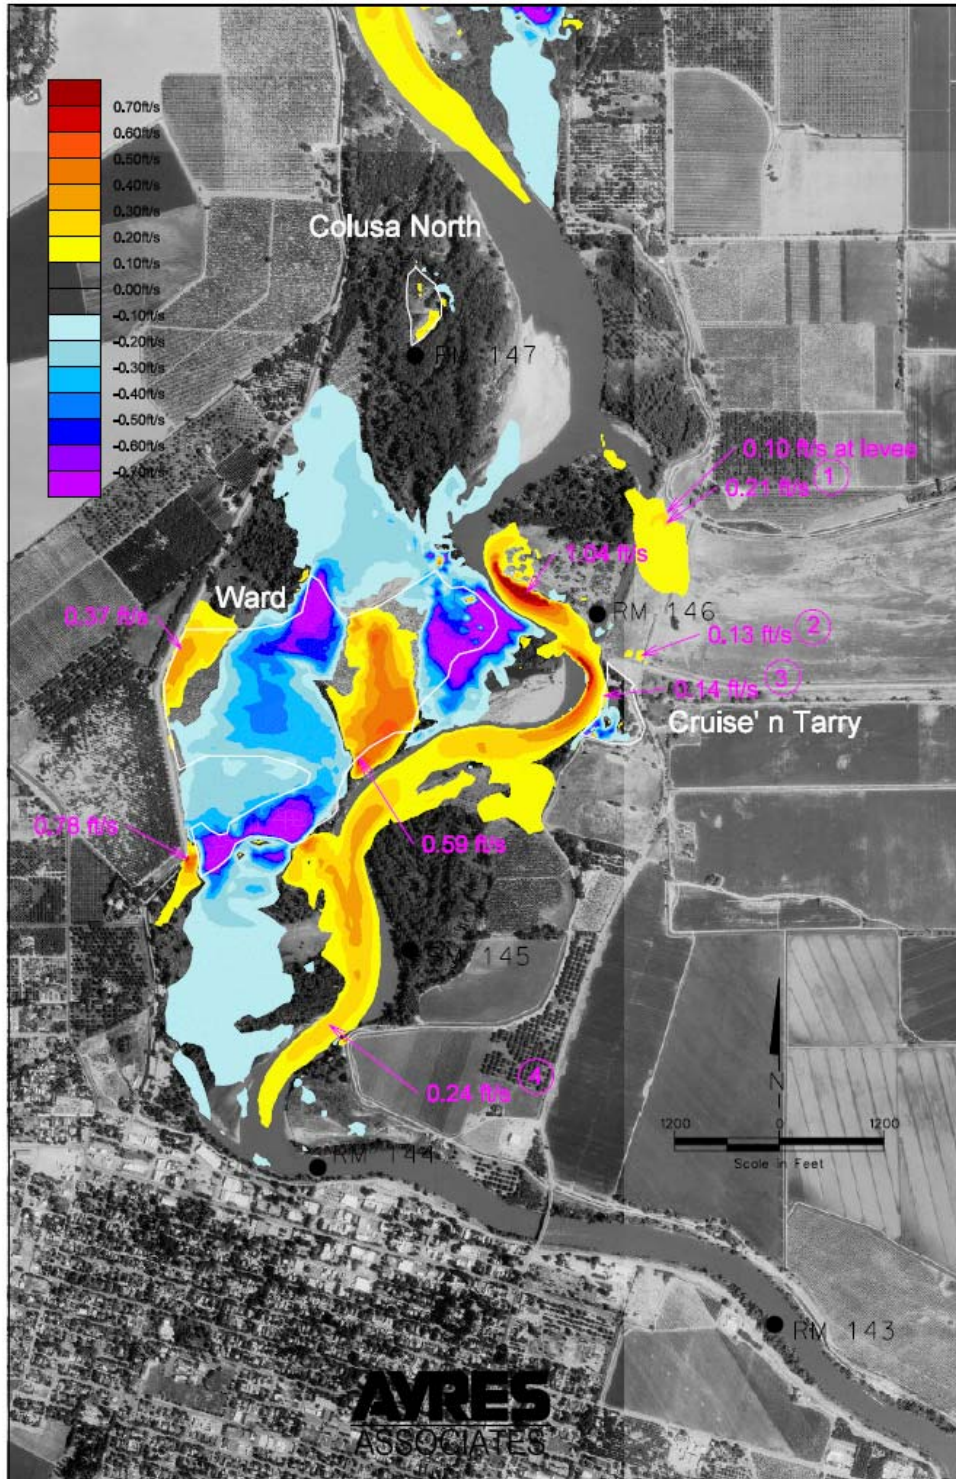
- Net changes in velocity modeled to occur if the project is implemented are shown in **Figure 13**. The difference between existing conditions and restored conditions (with project) modeled velocity distributions is sometimes positive, and sometimes negative. In other words, the graphic depicts show some increases in velocity (shown in warm colors) and some decreases in velocity (shown in cool colors).

- Some velocity increases shown in **Figure 13** occur where, given the original, existing condition velocities shown in **Figure 12**, they are not significant.

- Three of the areas of velocity increase shown in **Figure 13** occur where original, existing condition velocities are low. There are two areas along the western levee (note the 0.37 ft/sec and 0.78 ft/sec call outs in **Figure 13**). The third occurs in the “overbank flow corridor” of low hydraulic roughness vegetation (grass and savannah) that runs through the center of Ward Tract in the proposed restored condition.

- Velocity increases also are shown in **Figure 13** in the main channel for approximately two river miles adjacent to and downstream of Ward Tract. The maximum velocity increase is called out, at 1.04 ft/sec, across from the entrance to Colusa Bypass.

**Figure 13: Net changes in velocity; Difference between modeled Existing Conditions (Without Project) and Restored Conditions (With Project) velocity distributions (Ayres Associates)**

- Modeling results indicate that the restoration project would increase velocities by 0.1 to 0.14 ft/sec near levees at locations 1, 2, and 3, and 0.24 ft/sec at location 4. (See **Figure 13**). These are relatively small velocity increases. Just as all four locations are competent to withstand the projected existing conditions (without project) velocities under the modeled scenario, they are competent to withstand the increased velocities under restored conditions (with project).

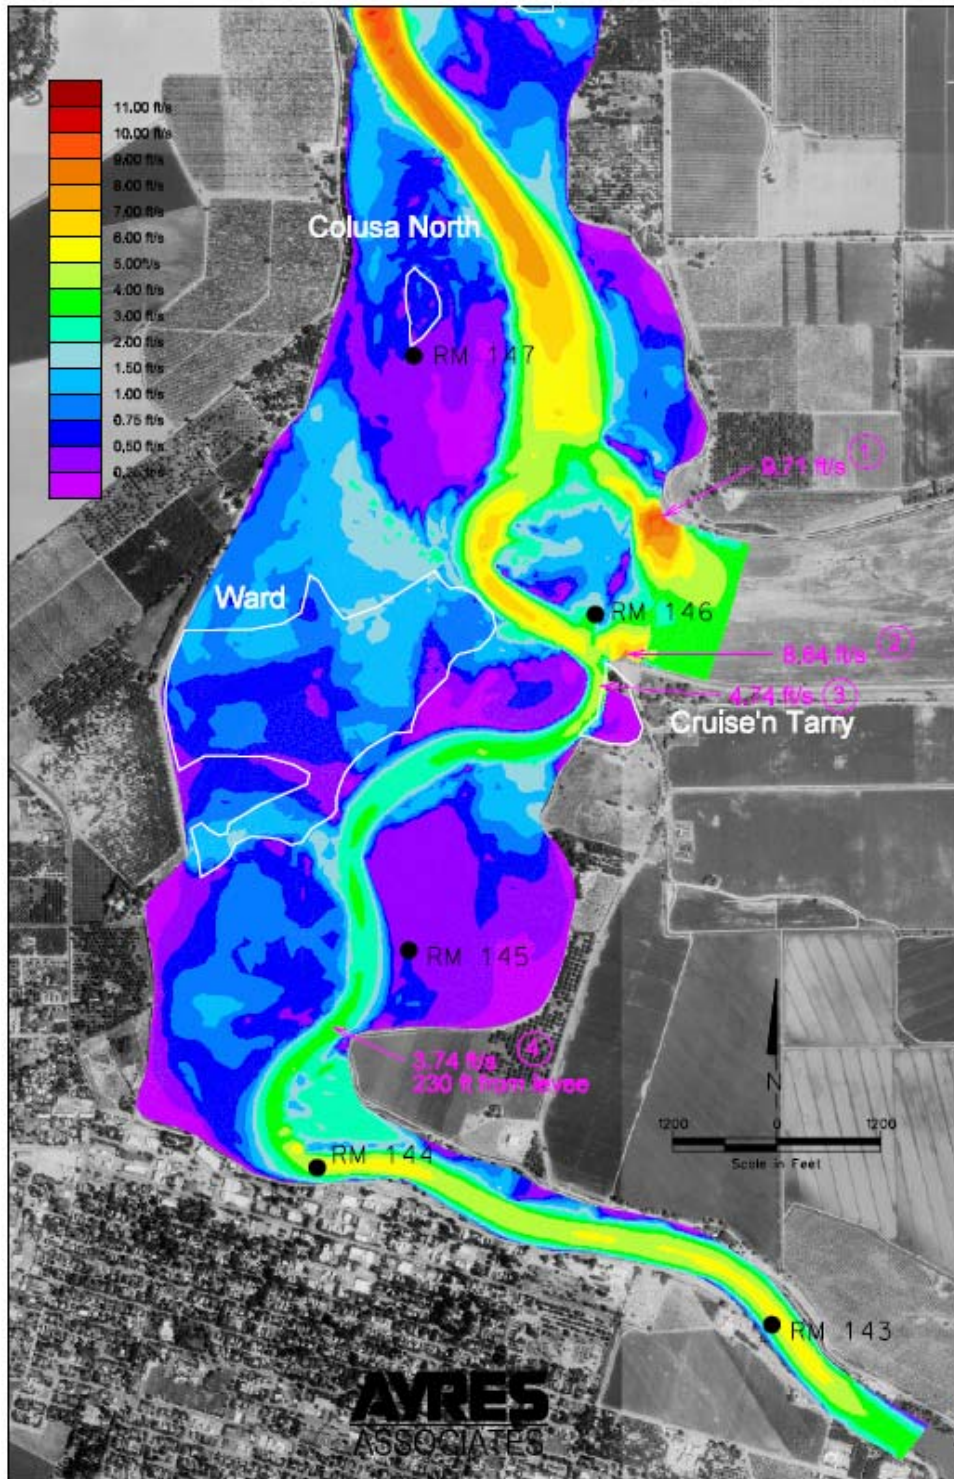
- The areas of greatest reduction in velocity are concentrated within the Ward Tract. (See **Figure 13**). The resultant velocities under restored conditions (with project) are shown in **Figure 14**. In side by side comparison of **Figure 14** with **Figure 12**, what stands out most is the increase in in-channel velocities.

- Resultant maximum velocities maxima at the four sites where there is existing potential for concern are called out in **Figure 14**:
  - Location 1, along northern levee at entry of Colusa Bypass: 9.71 ft/sec

- Location 2, along southern levee at entry of Colusa Bypass: 8.64 ft/sec
  - Location 3, Cruise 'n Tarry: 4.74 ft/sec
  - Location 4, main channel near levee at river mile 144.6: 3.74 ft/sec 230 ft from levee.

Figure 14: Restored Conditions (With Project) modeled velocity distribution (Ayres Associates)
